# Circuit Breaker Nuisance Tripping: Demonstrating Onsite Investigation Techniques

by Jude M. Russell / PowerLines

A 480 VAC / 70 Amp circuit breaker, feeding a sheet metal Press Brake, was tripping intermittently during normal equipment operation, resulting in lost data, equipment downtime, and manufacturing process interruption.

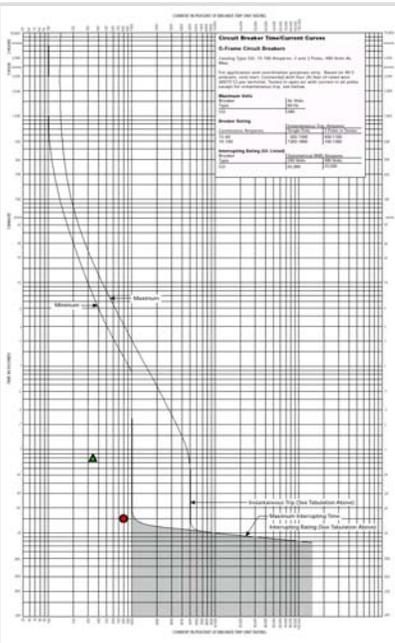
Left: Trip curve of Cutler-Hammer circuit breaker showing proximity of measured inrush currents to lower limit of breaker trip curve.

4. The circuit breaker was found to be functioning normally, and the current swell was normal. The current was simply too close to the lower limits of the breaker trip curve.

- a) Install a different breaker device with a higher magnetic trip rating, adjacent to the main distribution panel (this was the solution that was successfully implemented).

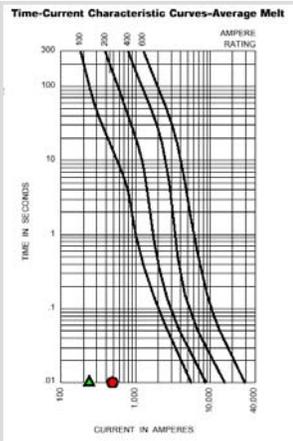
Below: Trip curve of Bussmann Fuses shows that a trip on this device would be highly unlikely.
