Mains Impedance measurements can effectively detect and isolate loose electrical connections.

A Cancer Treatment Center was experiencing system problems with their Linear Accelerator. Output dose was fluctuating, requiring frequent re-calibration. This affected the patient throughput, interrupted treatment plans, and impacted the cancer center's profitability.

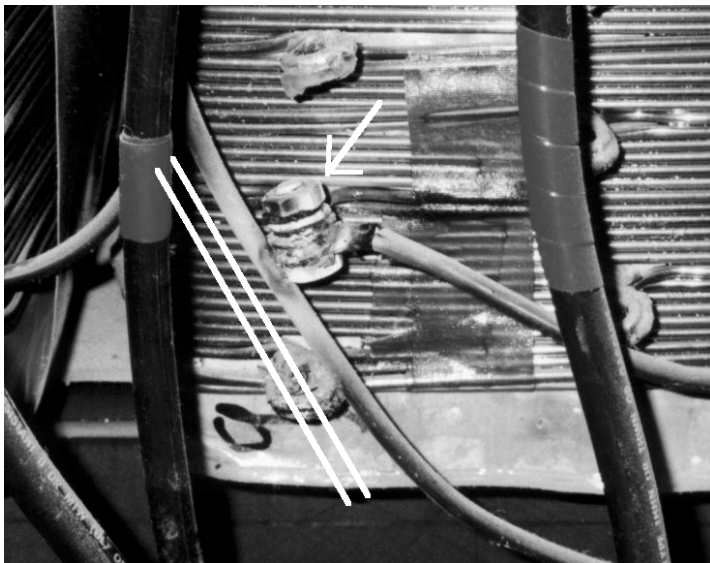
By measuring the impedance at multiple points along the feeder circuit, the problem was isolated to the primary side of a 30 kVA isolation transformer. Close inspection of this device identified a loose connection that was in the process of overheating. This connection was causing impulses, voltage imbalance, and waveshape distortion, which were causing the Linear Accelerator problems.

The arrow points to the transformer tap itself. The copper coil and connection wire in the vicinity of the tap also show signs of heating (conducted from the tap), resulting in a blackening of the transformer tape and a degradation of the wire insulation.

More dangerous - the adjacent conductor (parallel to the white lines) is a different 480 VAC phase. This wire is touching the overheated tap, and shows signs of insulation degradation and heating. A short circuit from this wire to the tap would cause a circuit breaker trip (best case) resulting in short term loss of Linac use. In worst case, this short circuit could cause an arcing fault that could damage or destroy the transformer, or possibly start an electrical fire.

Cleaning and tightening the connection eliminated the equipment problems, saving the customer close to \$15,000 that would have been spent on a voltage regulator.

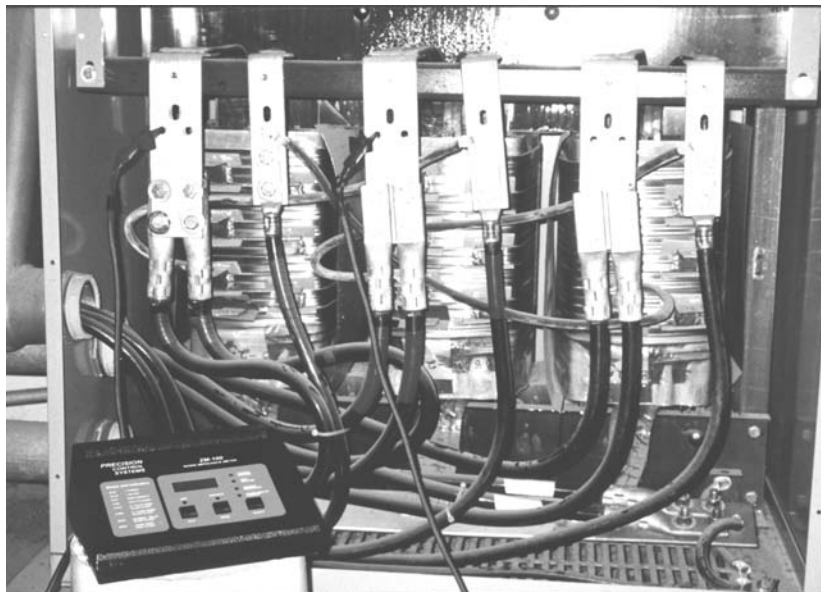
The ZM-100 is designed to measure impedance on 120 to 480 VAC systems safely and quickly. At left, the ZM-100 is shown connected to the 208 VAC secondary of a 225 KVA transformer.
