White Paper PQube vs. Fluke 1750 On a Mobile MRI System

Background

A medical imaging OEM has installed a PQube power monitor in an MRI system, which has been installed in a mobile trailer. This system typically is used during daytime hours, and in the evening, travels to a different site. During the transit process, the trailer is removed from facility power (typically, a concrete pad with a large plug-in power source) and transferred to an on-board generator. Once arriving at the new site, the power is transferred back to facility power at the new site.

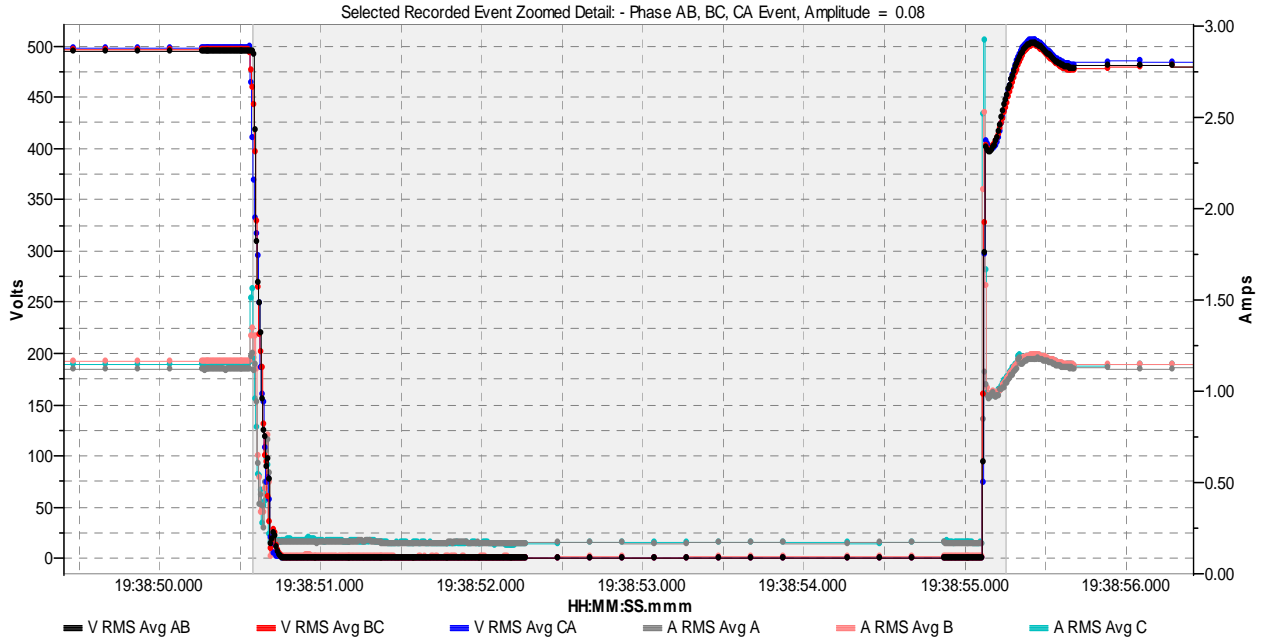
**Outage
 Event #
 1 - 2**

Outage related to transfer from facility power to on-board generator. Note instability / fluctuation of voltage while operating on generator.

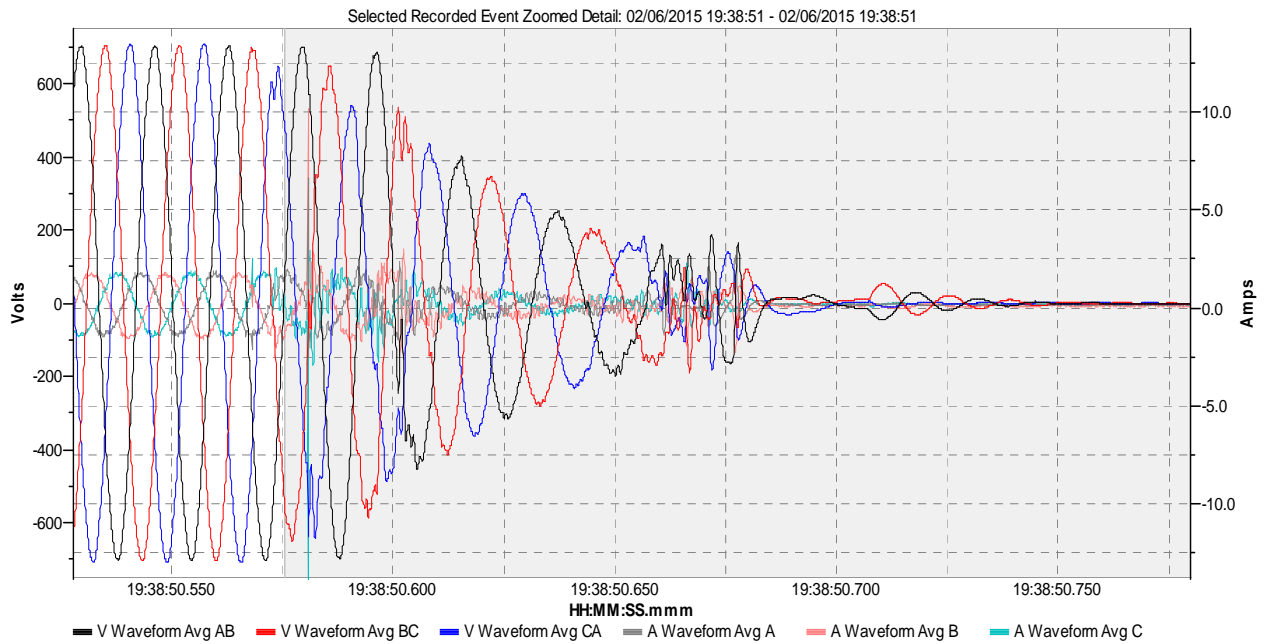
**Outage
 Event #
 1 - 2**

Slow decay of voltage during outage, probably related to power conditioner discharge of DC bus. Recommend switching sensitive equipment off during transfers to/from the on-board generator.

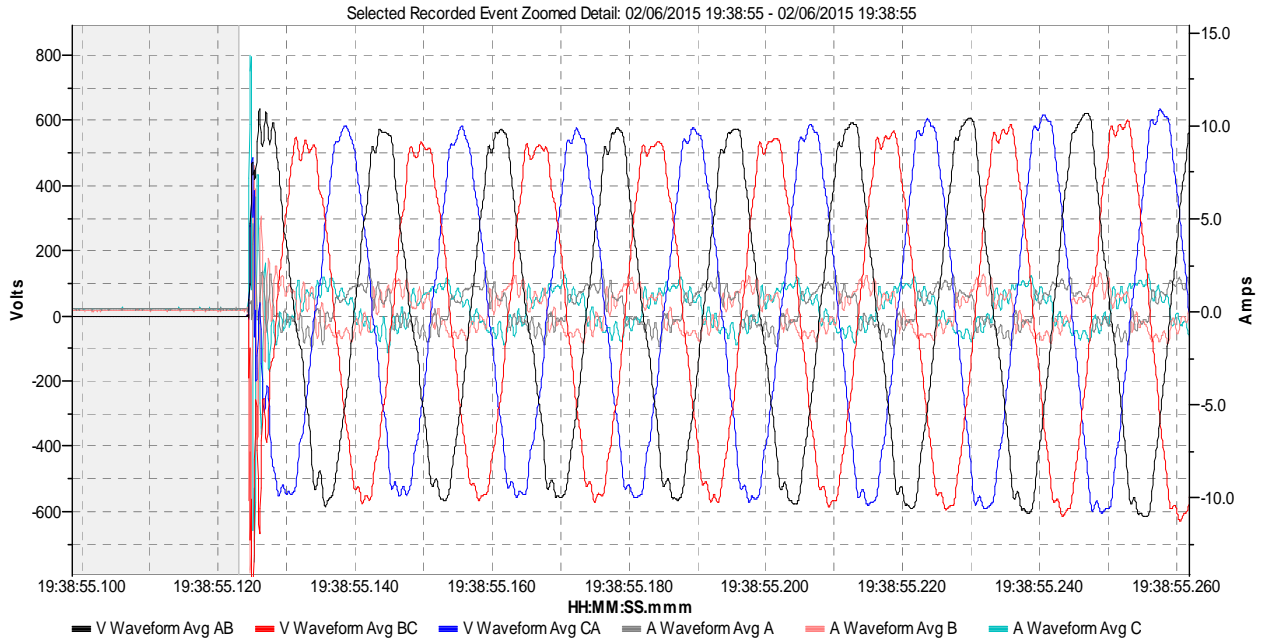
Outage
 Event #
 1 - 2

Voltage transfer to on-board generator, with transients, voltage instability, and voltage distortion. Suspect that on-board power conditioner is struggling to correct generator voltage instability.

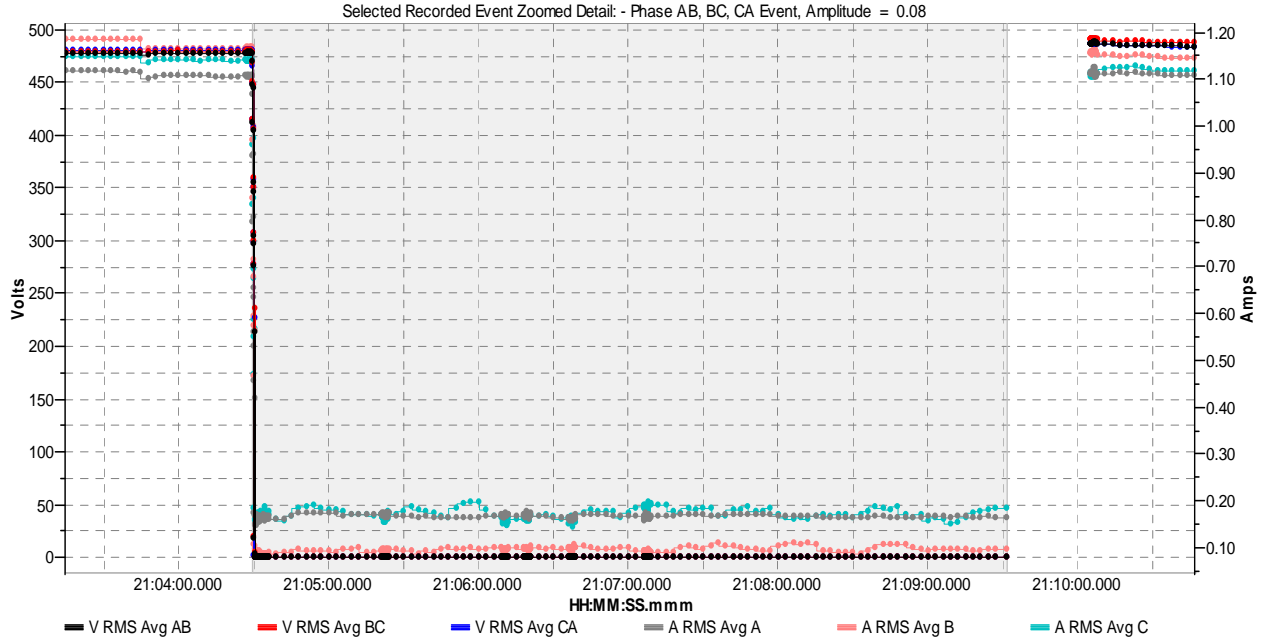
Outage
 Event #
 21 - 22

Voltage outage associated with transfer from on-board generator back to facility power.

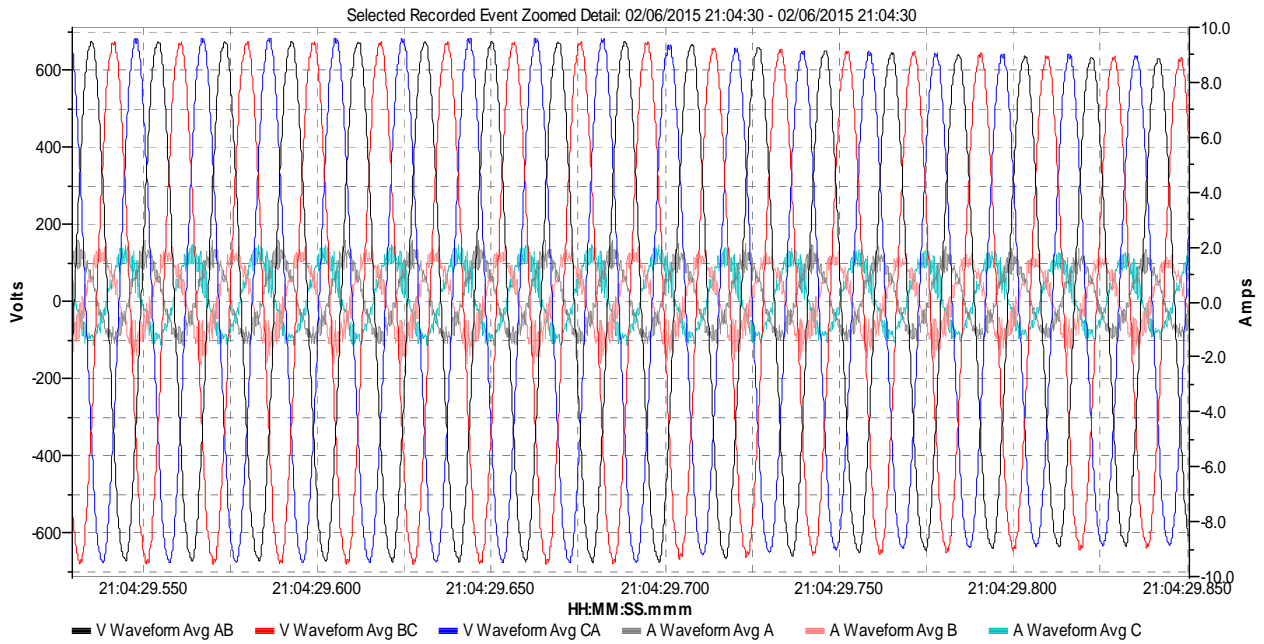
Outage
Event #
21 - 22

Long voltage decay, probably related to generator being switched off and allowed to run down over time. Best practice would be to switch power conditioner and/or medical imaging system off rather than allowing the generator to spin down over many cycles.

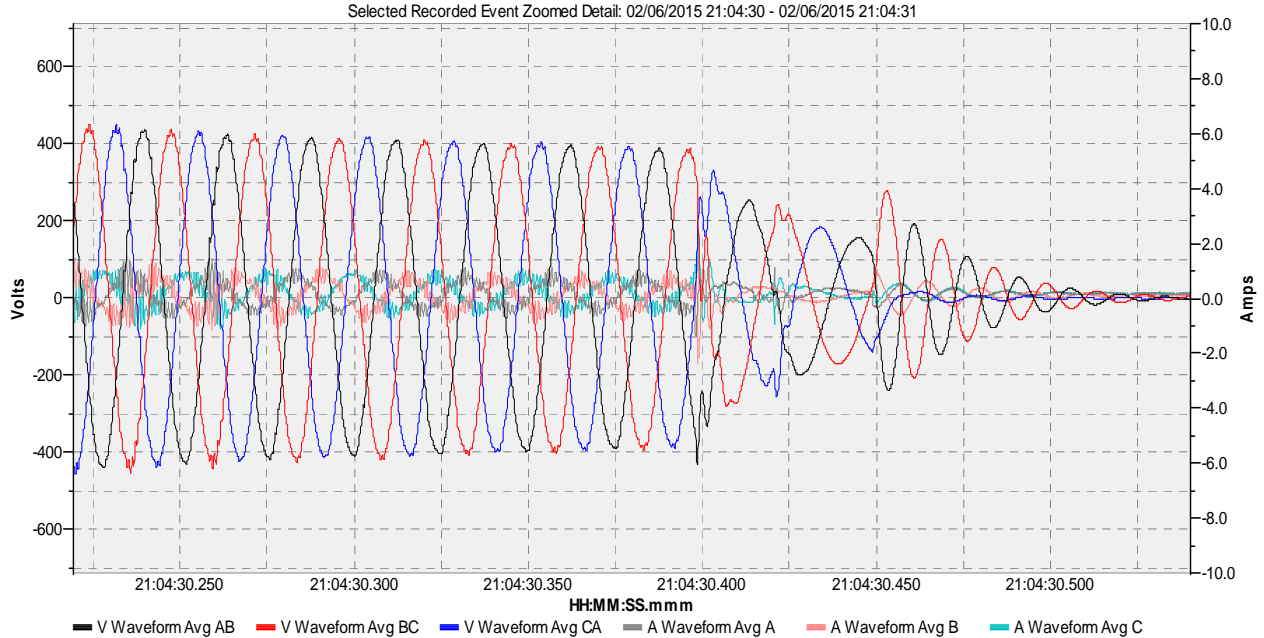
Outage
Event #
21 - 22

Slow decay of voltage during outage, probably related to power conditioner discharge of DC bus. Recommend switching sensitive equipment off during transfers to/from the on-board generator.

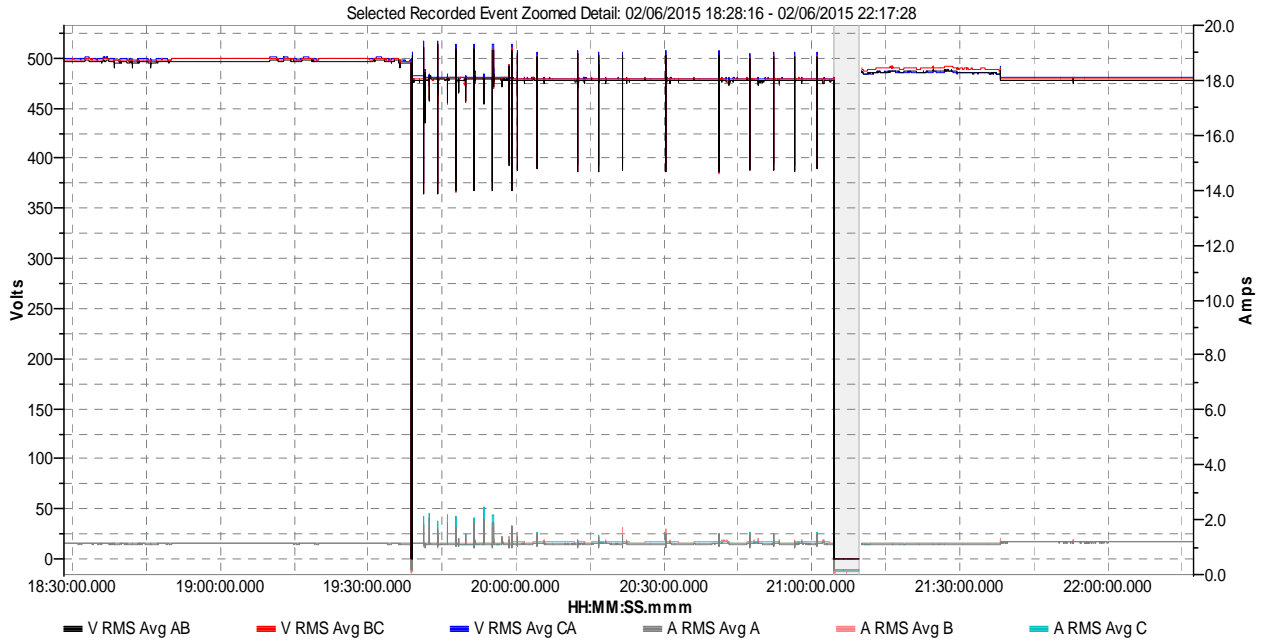
**Outage
Event #
1 - 22**

Mobile system move event: transfer from facility power to generator, generator operation, and a subsequent transfer back to facility power. During generator, voltage is well regulated (power conditioner) but many sag events were captured. Suspect generator is being overloaded by a cycling load (chiller, compressor, HVAC, etc.) and resultant sags are too severe for power conditioner to correct.

- During generator power, there was a periodic severe voltage sag (perhaps 10-20 per hour), which was causing the large number of PQube disturbance emails. It appears that there is a large, cycling load (chiller, compressor, or the trailer HVAC system) operating from the on-board generator, and causing a severe voltage sag when it cycles on (inrush current) that the power conditioner is unable to correct.

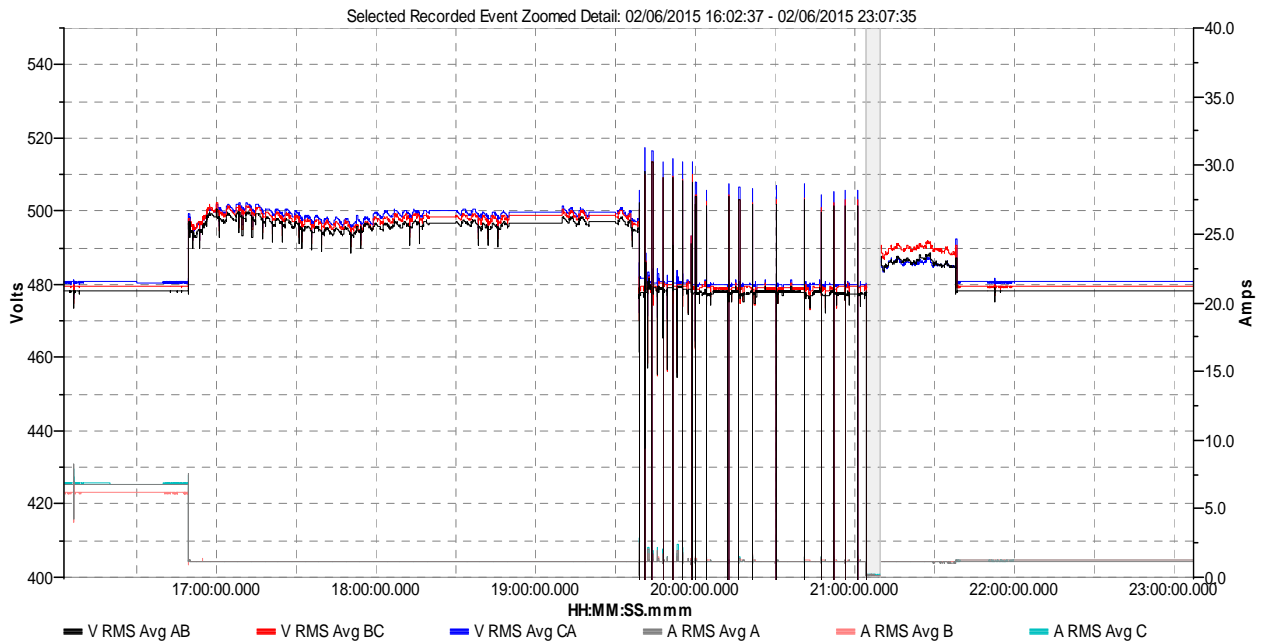
**Outage
Event #
1 - 22**

Power conditioner is switched to bypass mode before and after power transfers. Note higher and less regulated RMS voltage: 500 VAC before move, 490 VAC after.

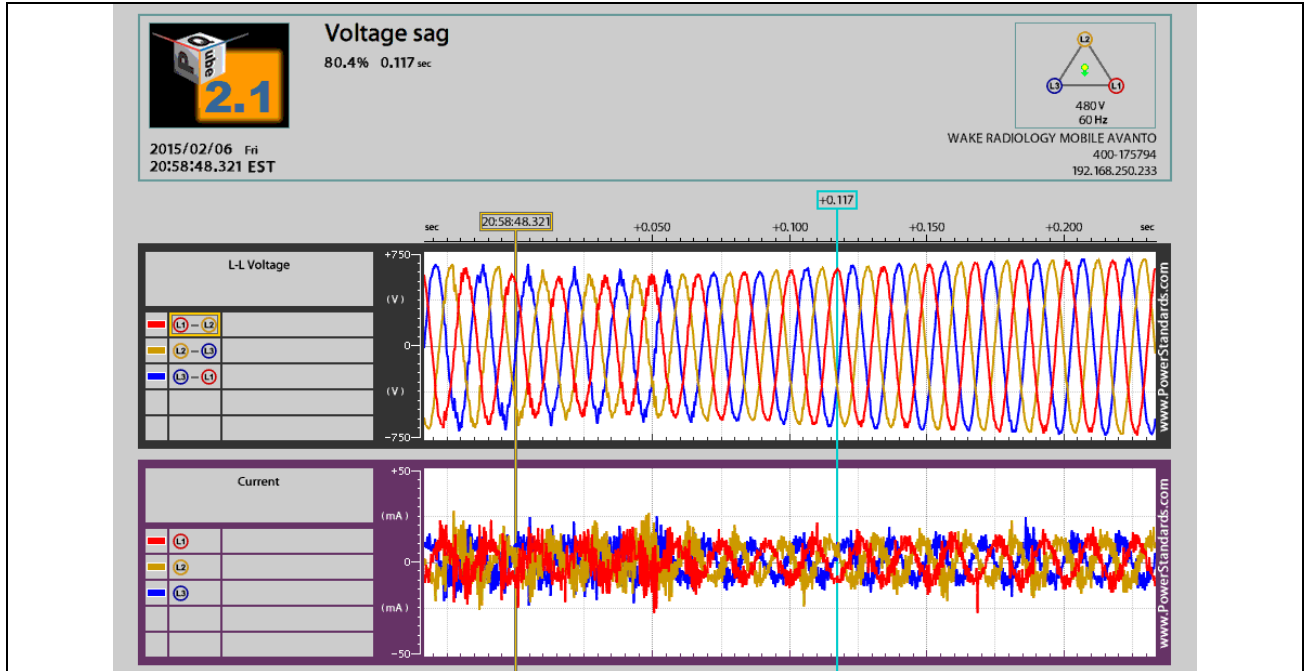
Above: PQube waveform graphs of a serious voltage sag, captured during operation from the on-board generator. A large number of similar sags were captured during each period of generator operation.

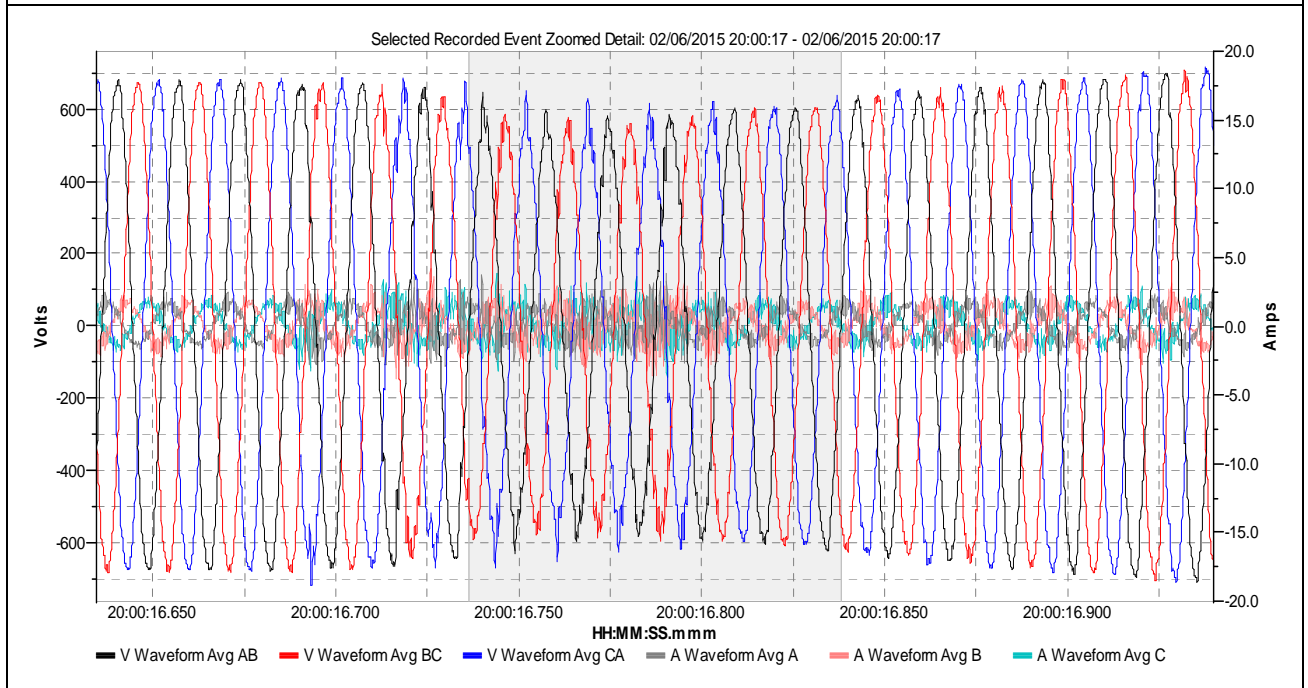
Below: Fluke 1740 documents severe voltage sag / collapse. Unusual for the output of a power conditioner, unless the source voltage collapse or instability is too great for the device to compensate. (Event #10)

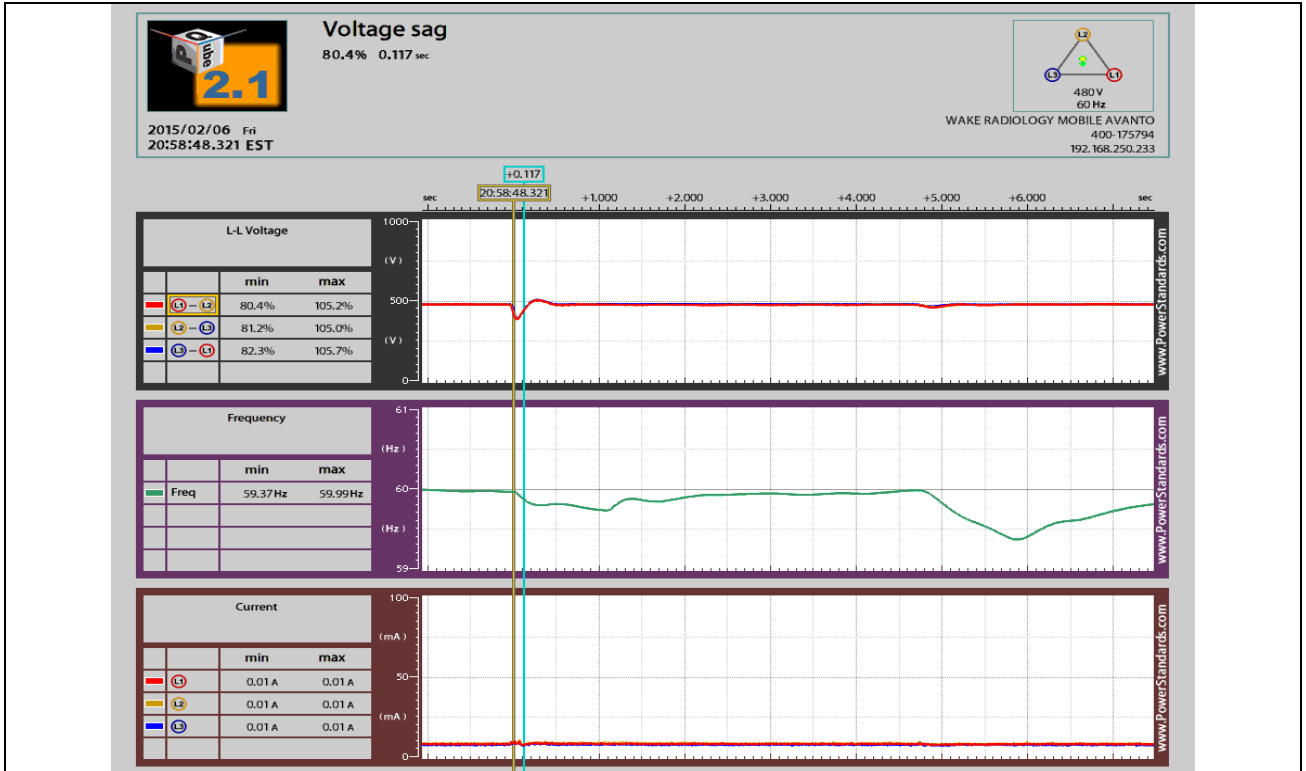
Above: PQube RMS logs of a serious voltage sag, captured during operation from the on-board generator. A large number of similar sags were captured during each period of generator operation.

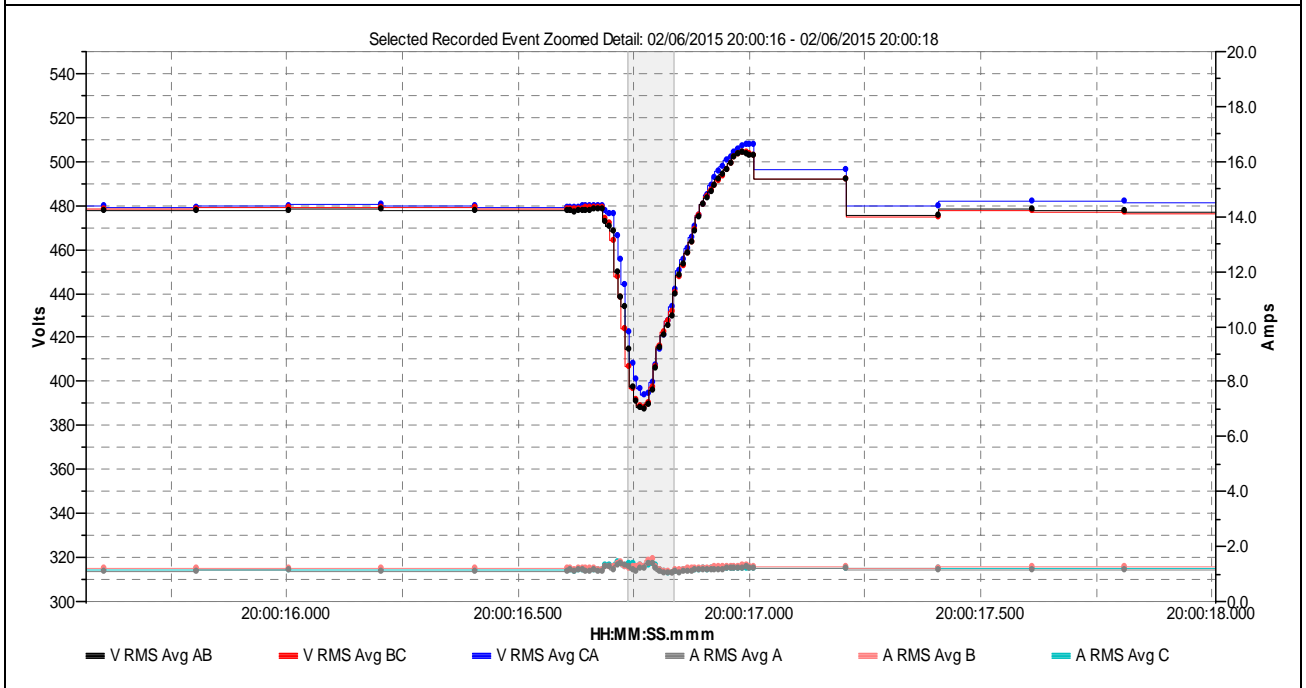
Below: Fluke 1750 RMS sag / swell event - with severe voltage sag / dip, followed by an overvoltage swell (less severe) related to generator and/or power conditioner regulation characteristics. (Event #10)
