Mains Impedance measurements can effectively detect and isolate loose electrical connections.

A Cancer Treatment Center was experiencing system problems with their Linear Accelerator. Output dose was fluctuating, requiring frequent re-calibration. This affected the patient throughput, interrupted treatment plans, and impacted the cancer center's profitability.

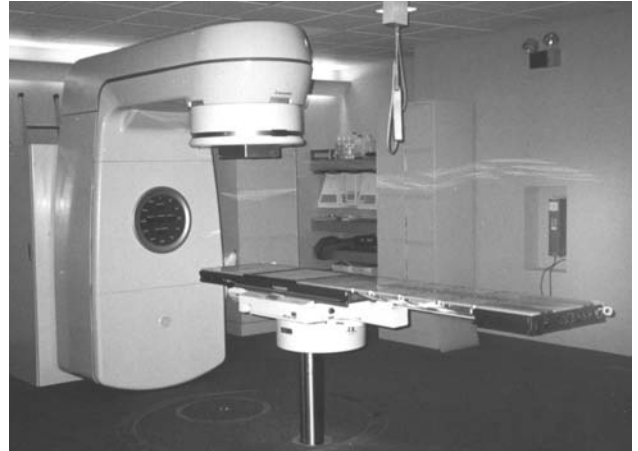
A ZM-100 Mains Impedance meter was used to measure the mains impedance as part of a Power Quality Audit. In the course of measuring mains impedance, an imbalance was detected at the input to the Linear Accelerator. Since an imbalance in mains impedance is extremely rare, the Power Quality engineer began to "walk the line back" making impedance measurements at accessible points along the power feeder.

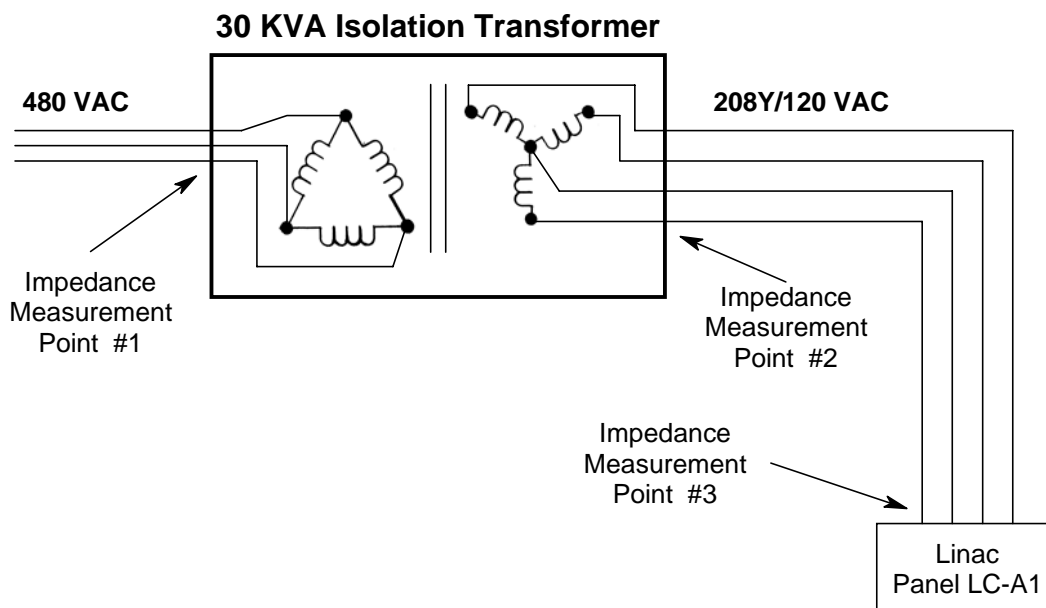
BOLD measurements above are unbalanced, and indicate a problem of some sort. Impedance imbalance was seen on the secondary side of the transformer as well as at the load, but not on the primary of the transformer. A loose connection was suspected within the transformer itself.
